Tennessee Valley Authority
Office of the Inspector General

Inspection Report

REVIEW OF THE KINGSTON FOSSIL PLANT ASH SPILL ROOT CAUSE STUDY AND OBSERVATIONS ABOUT ASH MANAGEMENT

2008-12283-02
July 23, 2009

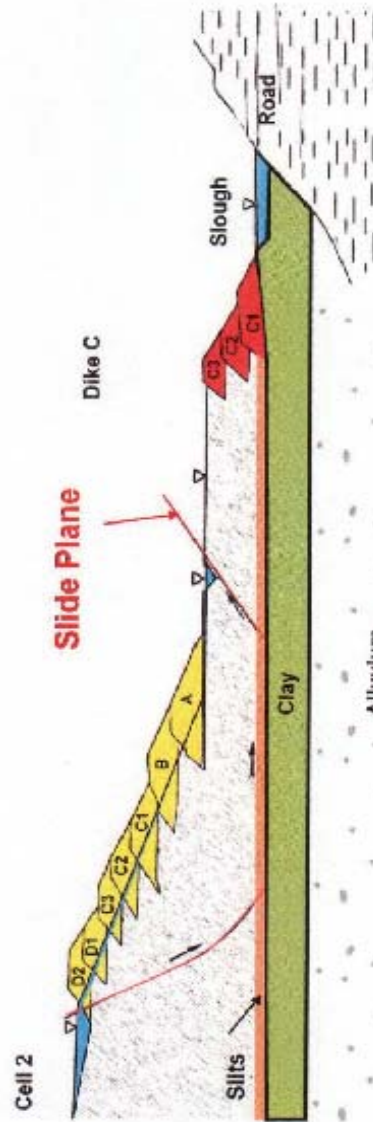
Figure 3

Stage 1 - Initiation of Failure at North Side of Dredge Cell 2

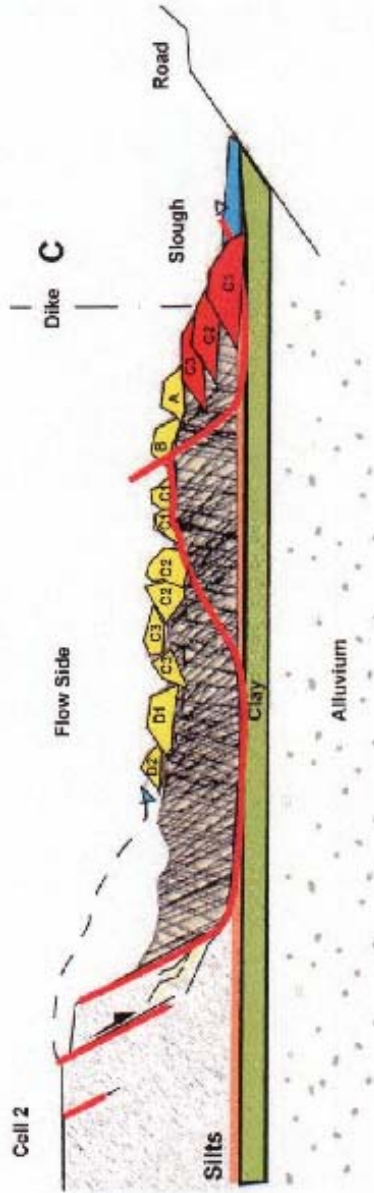
Stage 2 – Ash & Dikes A thru D2 Pile Up Against Dike C. This Surcharge and increased Ash Pressure Causes Dike C to Fail

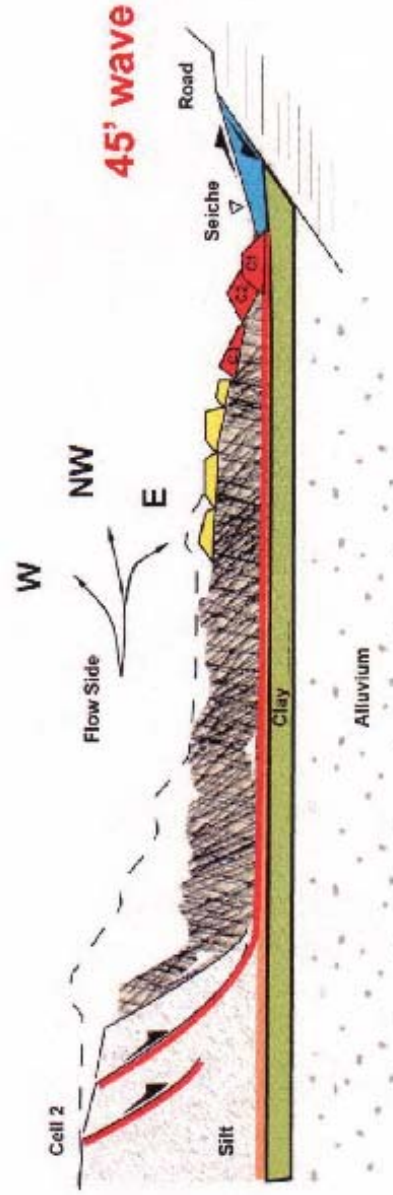
Figure 5

Stage 3 – Progressive Failure Southward that Fails North Dikes A thru D2 Back to Cell 1 Divider Dike. 5.4 Million CY Fill Sloughs and Reservoir
