FINAL REPORT – INSPECTION 2009-12910-01– PEER REVIEW OF STABILITY ANALYSIS OF DIKE C AT KINGSTON FOSSIL PLANT

Technical Rebuttal to May 11, 2010 TVA Response to OIG Draft Inspection
2009-12910-01 – Peer Review of Stability Analysis of Dike C at Kingston Fossil Plant

Tennessee Valley Authority Kingston Fossil Plant (KIF)
Harriman, Tennessee

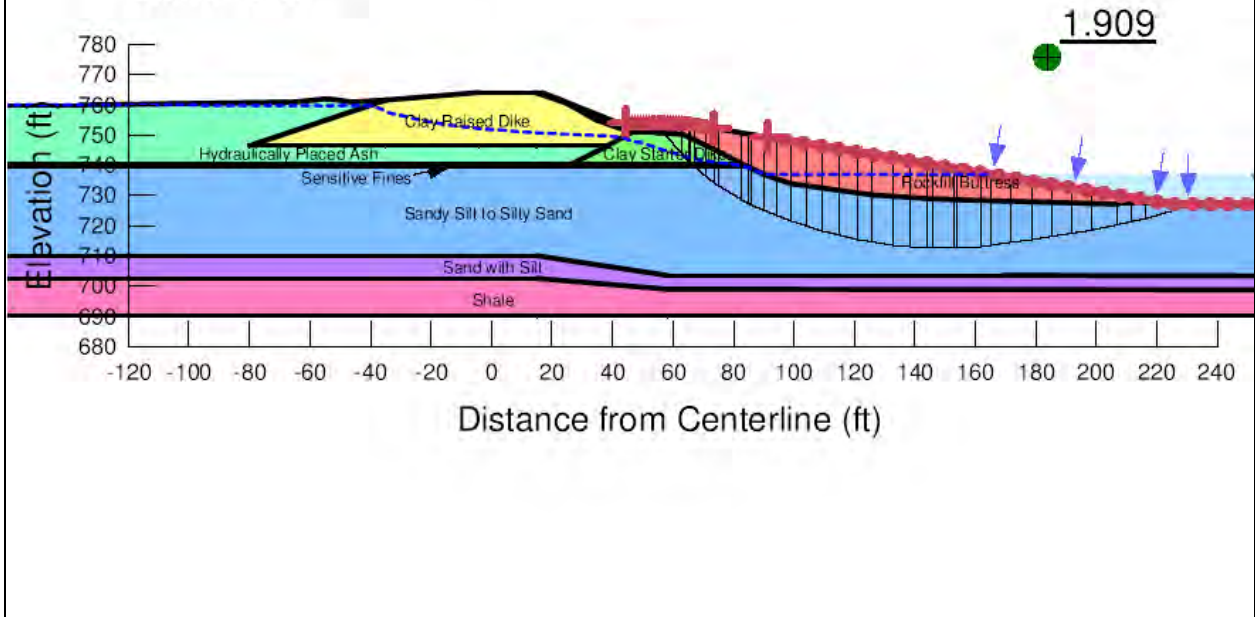
Figure 1
Kingston Fossil Plant
Dike C - Station 154+00
Starter Dike

The stability evaluation for the section at Sta 154+00 using the as-surveyed lake bottom geometry and with the buttress in place is shown on Figures 1 to 3 in Comment 4 Appendix with the results summarized in Table 4.2 below. This stability section was developed based on as-built surveyed ground geometry with subsurface soil conditions from the previously analyzed stability section at Sta 149+14. Using the same shear strength parameters and SEEP/W input file as outlined in Stantec's August 3, 2009 stability report, and under steady state conditions, the buttress design at this critical section satisfies the slope stability requirements, with Table 4.2 listing the estimated factors of safety for the various slip surfaces. The cross section at this location was also reviewed to ensure that the filter will provide an adequate factor of safety against piping. With the filter and buttress in place, the estimated factor of safety against piping is estimated to be 18.6 (Table 4.2) which is acceptable as per USACE 1110-2-1901.
