FINAL REPORT – INSPECTION 2011-14109 – REVIEW OF NON-TIME-CRITICAL KINGSTON ASH RECOVERY PROJECT ACTIVITIES

REVIEW OF NON-TIME- CRITICAL KINGSTON ASH RECOVERY PROJECT ACTIVITIES

Inspection 2011-14109
May 11, 2012

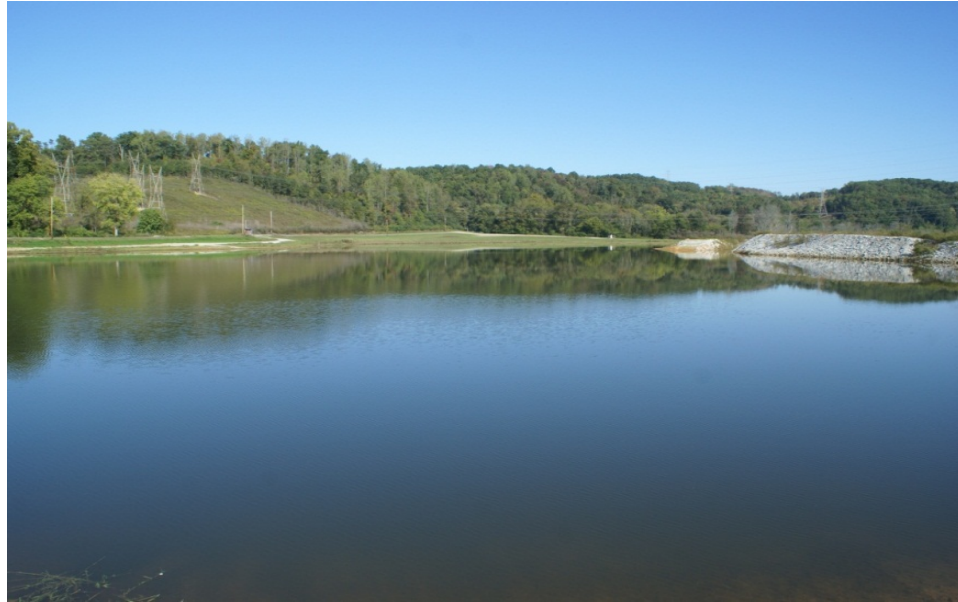
Figure 1: Restored North Embayment

TVA has completed ash removal in the North Embayment, which began in November 2010. The work plan for the North Embayment included removing ash and restoring the area to pre-spill conditions. In order to confirm that TVA had completed ash removal in this embayment, testing was required to make sure the level of ash in the soil met EPA criteria. On December 7, 2011, TVA received signed confirmation from EPA that the North Embayment met the required criteria. The North Embayment has since been filled with water, as seen in Figure 1.

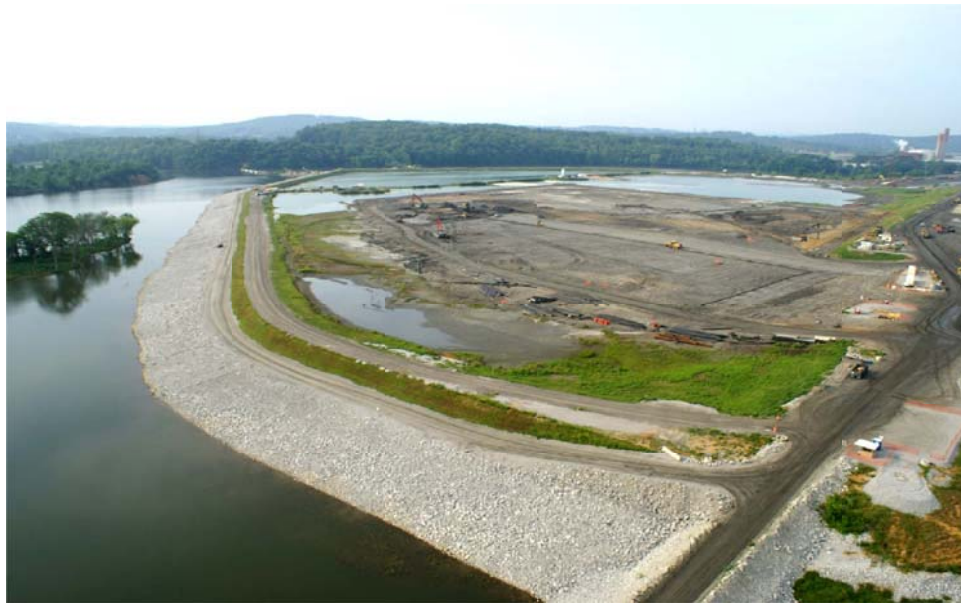
Figure 2: Completed Dike C

During the time-critical phase, Stantec Consulting was commissioned to inspect and evaluate the structural integrity of ash storage facilities at all TVA fossil plants. Stantec conducted a study to evaluate the stability of Dike C at KIF. This study found that the condition of Dike C did not exhibit acceptable factors of safety for long-term stability. Therefore, Stantec recommended that “TVA build a buttress on Dike C, which surrounds the ash collection pond and the stilling pond, in order to improve the overall safety of the dike.” In order to accomplish the goal, TVA needed to add layers of sand, stone, and Class B⁴ riprap along Dike C. This added thickness and weight to the dike, which increased resistance to movement and strengthened the dike. The reinforcement of Dike C began in December 2009 and was completed in October 2011. Figure 2 shows the completed Dike C.

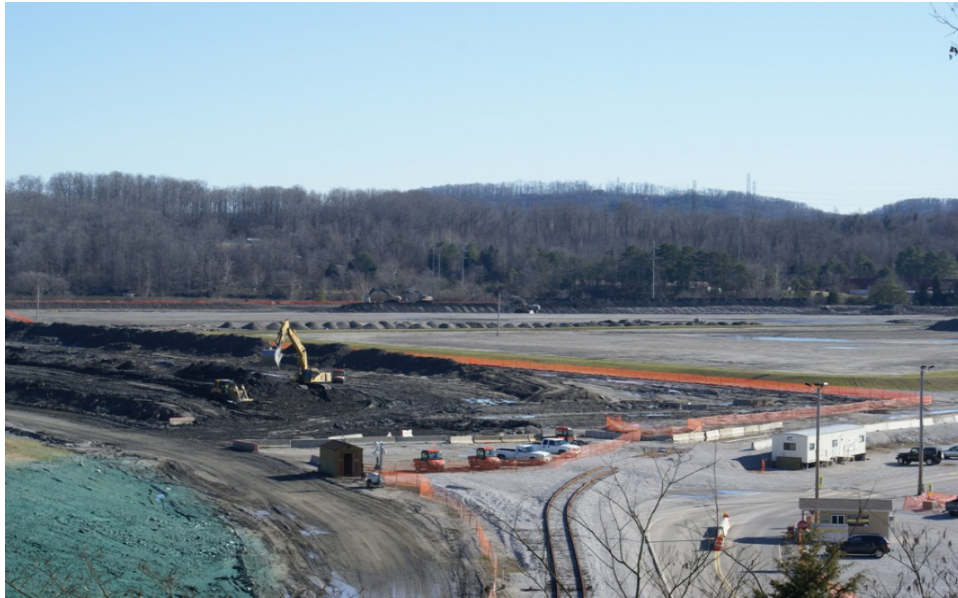
Figure 3: Ball Field

During the time-critical phase, ash was placed on the ball field to dry before being loaded into rail cars for transportation to the landfill in Alabama. Currently, it is being used for moisture conditioning of the non-time-critical ash that is being removed from affected areas, such as the embayments. A portion of the ball field was turned back over to KIF on November 11, 2011, to be used for the dry fly ash system conversion project. In order to turn the ball field over to KIF, remaining ash was placed in the on-site disposal area, and the field was contoured to a new elevation. Figure 3 shows the ball field.

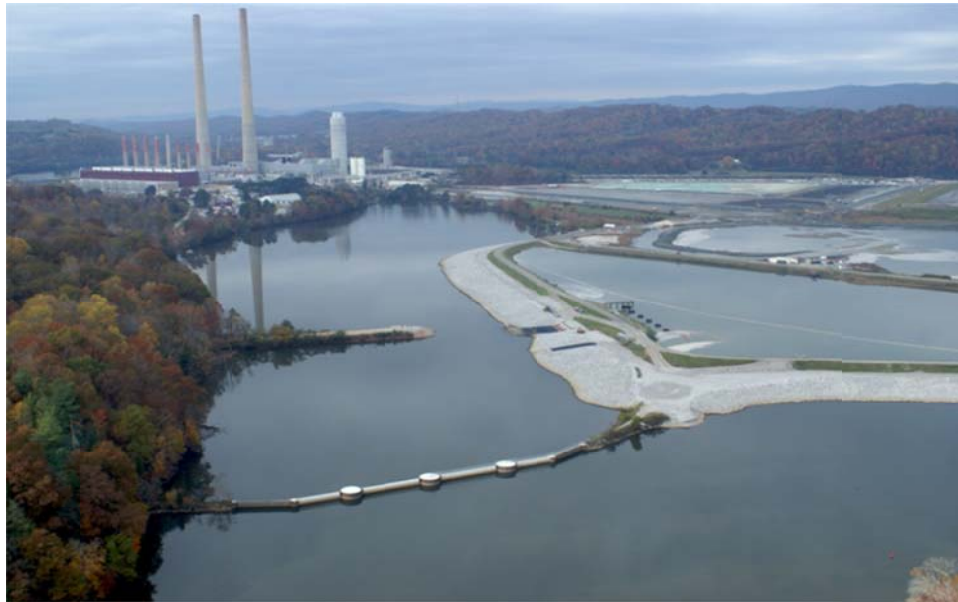
Figure 4: Skimmer Wall and Intake Channel

The skimmer wall located inside the intake channel at KIF was damaged during the ash spill and has been replaced as seen in Figure 4. The skimmer wall allows cool water to enter the intake channel for use in plant processes and blocks debris from entering the intake. The construction of the skimmer wall began June 24, 2010, and was completed on December 3, 2010.

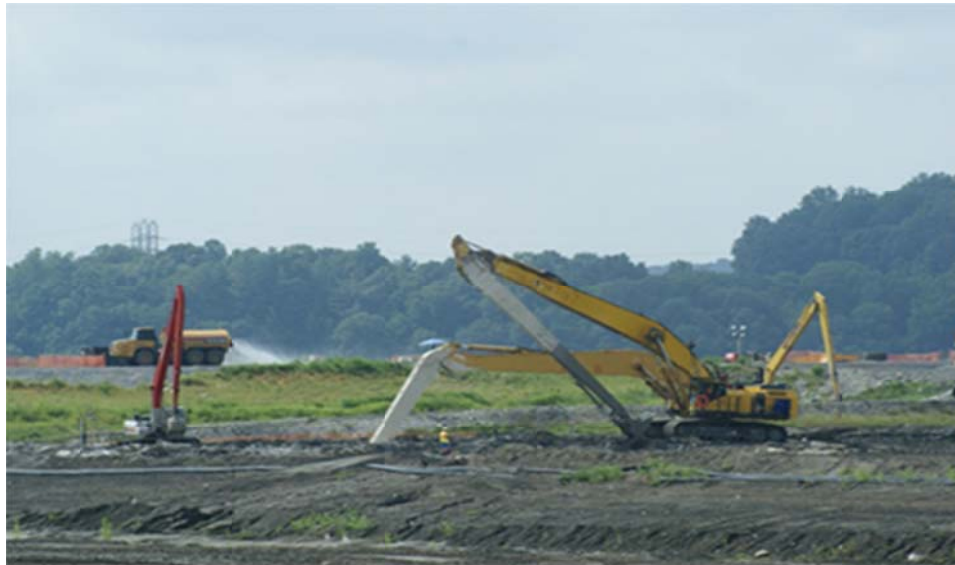
Figure 5: Construction of the PWS

TVA contracted with Geo-Con⁵ to build a stabilized perimeter containment around the Ash Pond, Lateral Expansion, and Dredge Cell areas. The PWS is an underground wall that extends 2-3 feet into the shale bedrock and is being created using a slurry trenching method.⁶ The PWS is being built, as seen in Figure 5, to prevent ash from releasing outside the ash landfill and is designed to mitigate factors that contributed to the failure of the former Dredge Cell. The wall is designed to withstand a 6.0 earthquake on the East Tennessee Fault and a 7.6 earthquake on the New Madrid Fault.

A demonstration was performed in order to provide information necessary to refine the wall design. For the demonstration, Geo-Con built a segment of the PWS, which was then thoroughly tested for stability and strength. The construction of the demonstration wall began on April 11, 2011, and ended April 20, 2011. The results of the testing showed the demonstration wall did not meet strength requirements, and the specifications needed to be improved. New specifications were submitted to the EPA on July 11, 2011, and TVA started building Segment 1A of the PWS on July 19, 2011. However, the approval for the new specifications was not signed by the EPA until August 4, 2011.

According to TVA management, the construction of the PWS has become a hard spot. Engineering design, which is proceeding in parallel with construction, has resulted in higher than previously estimated material quantities. It has also been necessary to increase slurry strength in order to accommodate uncertainties in field testing of the material. Finally, wet weather and unexpected subsurface conditions have increased difficulty of PWS installation in some areas. Each design phase goes through site, corporate, and regulatory reviews, which also have some impact on the schedule for design delivery. TVA management indicated that numerous activities are underway to address this hard spot, including the installation of wick drains⁷ to improve wet conditions on and below the working surface.

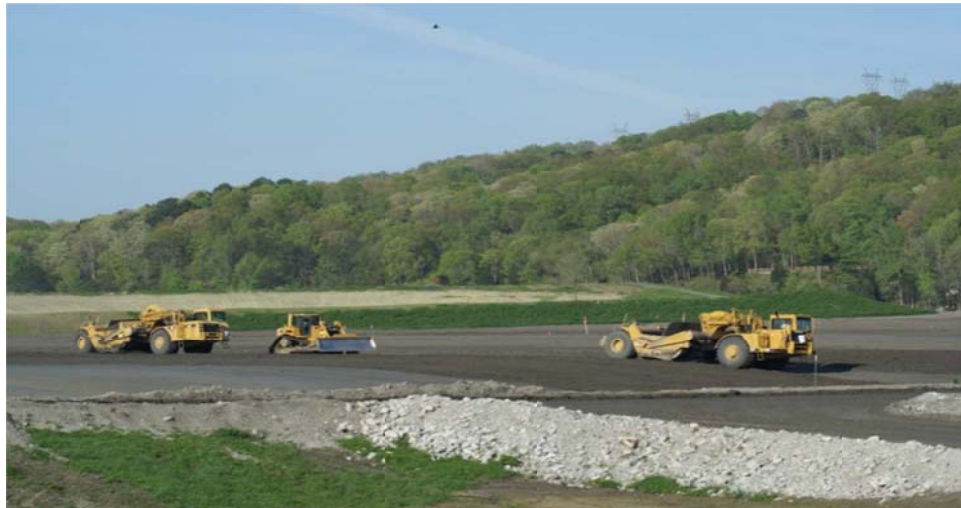
Figure 6: Ash Stacking in On-site Disposal Area

Currently, TVA is in the process of stacking ash in these on-site disposal areas, as seen in Figure 6. Once all ash has been stacked into the on-site disposal areas, the Dredge Cell, Ash Pond, and Lateral Expansion will be closed in accordance with the Tennessee Solid Waste Rule 1200-1-7.⁸ The closure will include a soil cover and a geosynthetic liner system. The cap will then be seeded and mulched.
