Tennessee Valley Authority
Office of the Inspector General

Inspection Report

REVIEW OF THE KINGSTON FOSSIL PLANT ASH SPILL ROOT CAUSE STUDY AND OBSERVATIONS ABOUT ASH MANAGEMENT

2008-12283-02
July 23, 2009

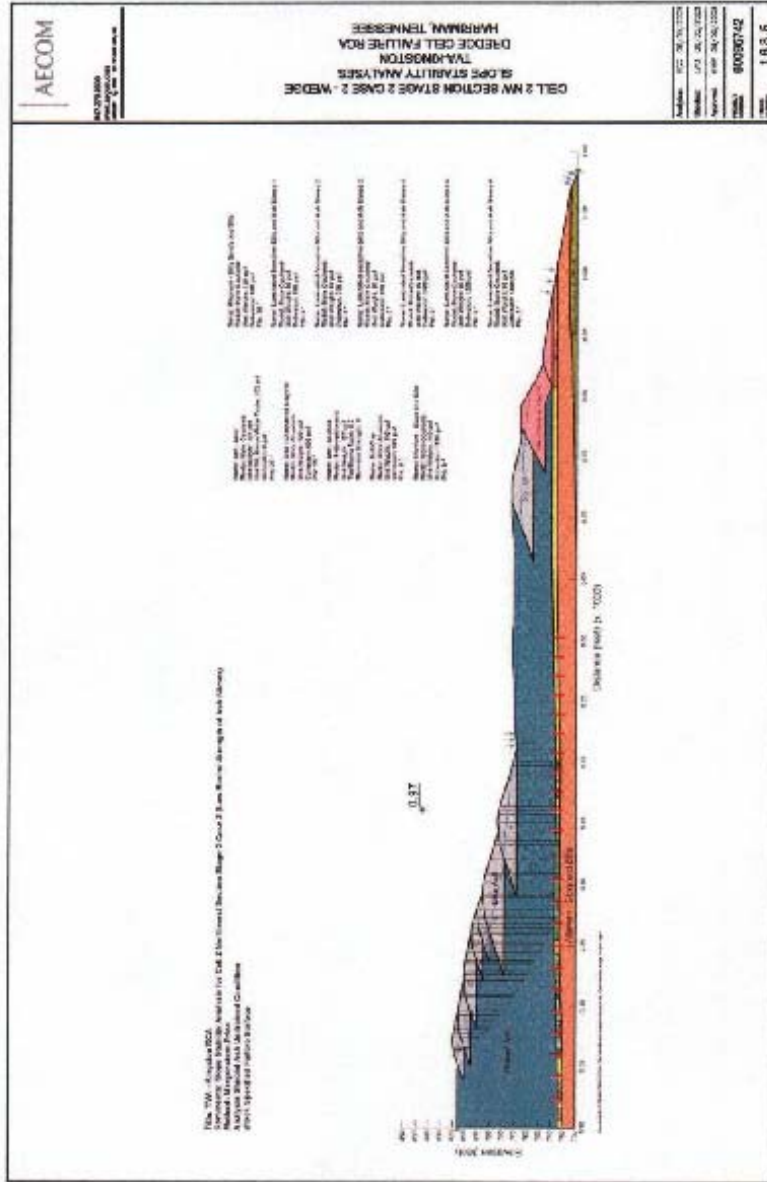
Final Review of the 2009-2010 Annual Assessment of TVA Kingdam
TVA Kingdam Assessment Report
Tennessee Valley Authority - Office of the Inspector General
July 2010 - Prepared by Metropolitan Associates, Inc.
Figure 1

Source:
Figure 1.6.1.5 from Volume 1 of "Root Cause Analysis of TVA Kingdam Dredge Fund
Failure on December 22, 2008" by AECOM dated June 25, 2009.

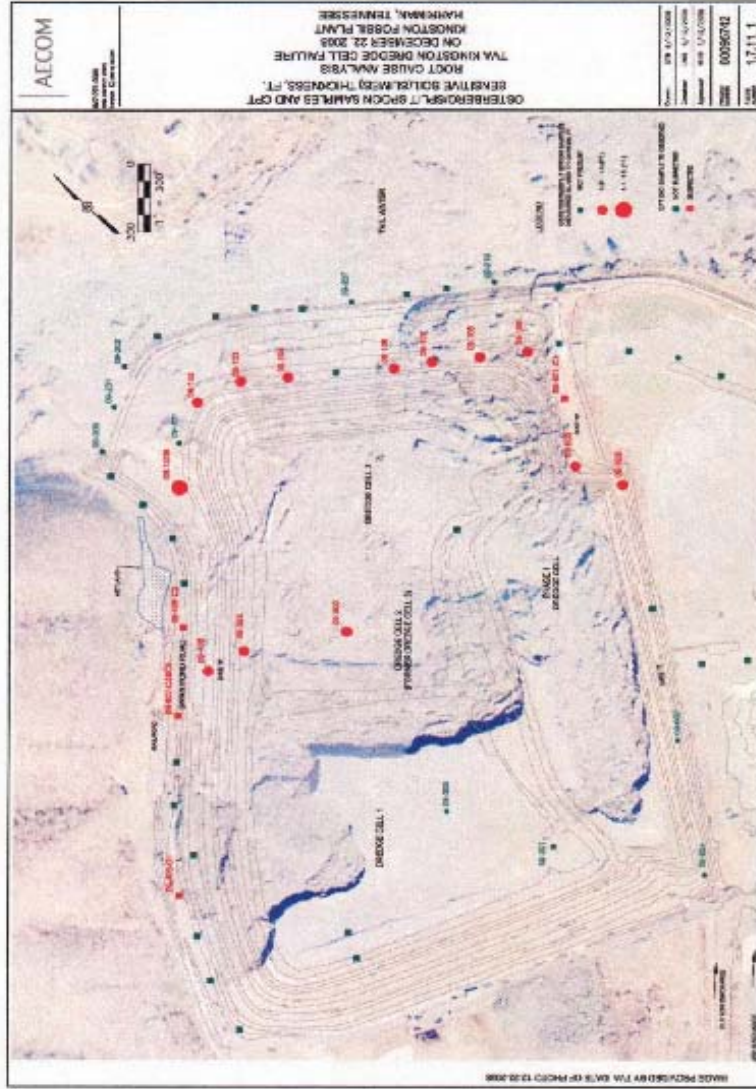
Figure 1

Source:
 Figure 1.7.1.1.1 from Volume 1 of "Root Cause Analysis of TVA Kingston Dredge Pond Failure on December 21, 2008" by AECOM dated June 23, 2009.

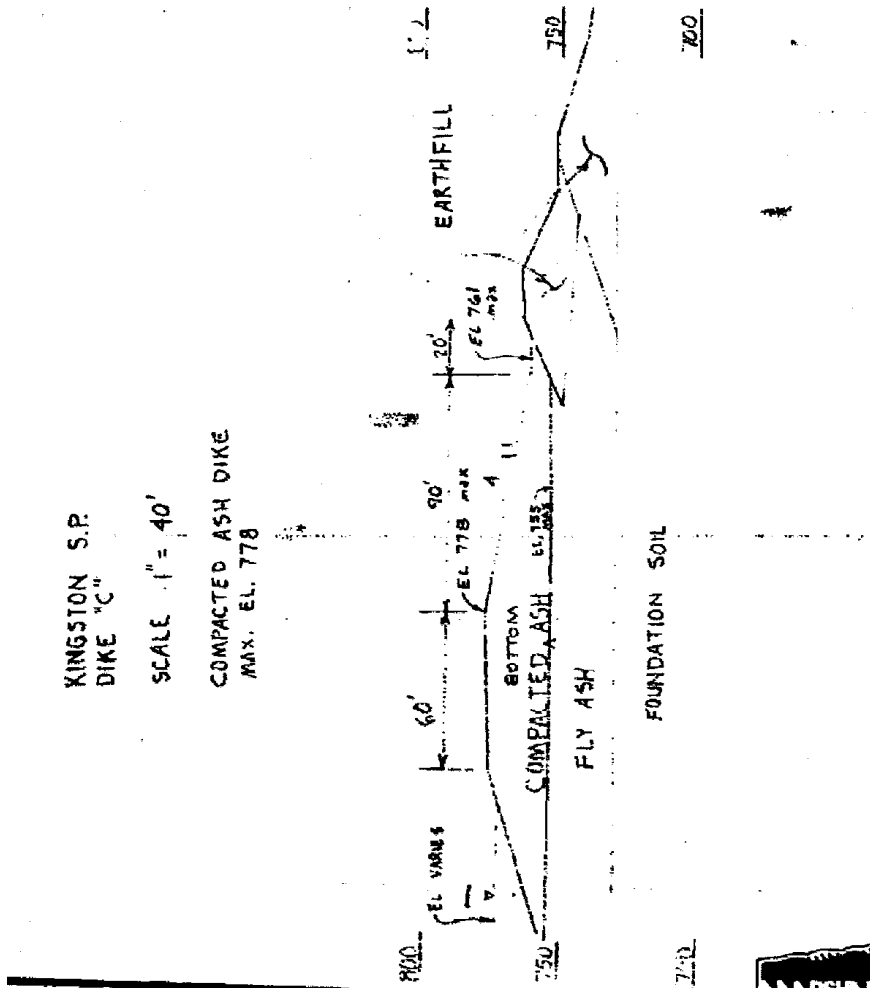
SUBJECT ATTACHMENT C PROJECT KIF

KINGSTON S.P.
DIKE "C"
SCALE 1" = 40'
COMPACTED ASH DIKE
MAX. EL. 778
