FINAL REPORT – INSPECTION 2009-12910-01– PEER REVIEW OF STABILITY ANALYSIS OF DIKE C AT KINGSTON FOSSIL PLANT

Technical Rebuttal to May 11, 2010 TVA Response to OIG Draft Inspection
2009-12910-01 – Peer Review of Stability Analysis of Dike C at Kingston Fossil Plant

Tennessee Valley Authority Kingston Fossil Plant (KIF)
Harriman, Tennessee

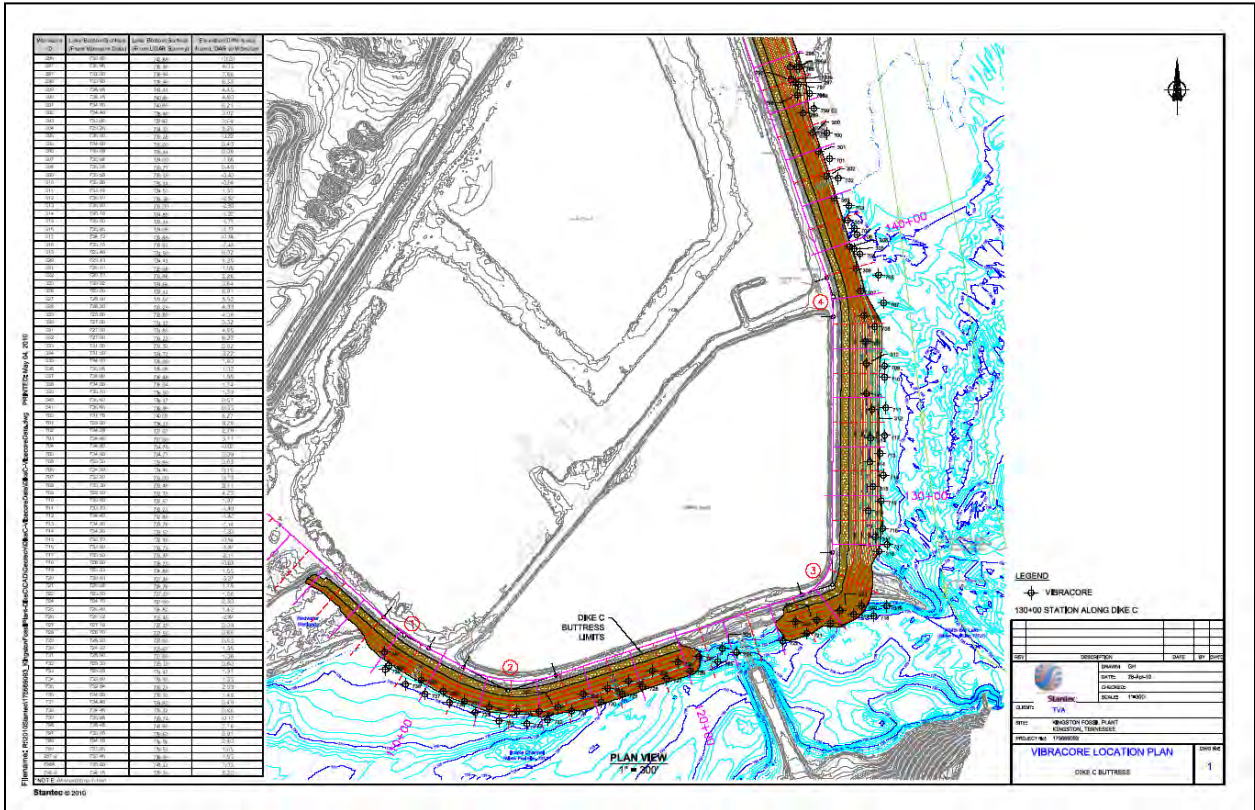
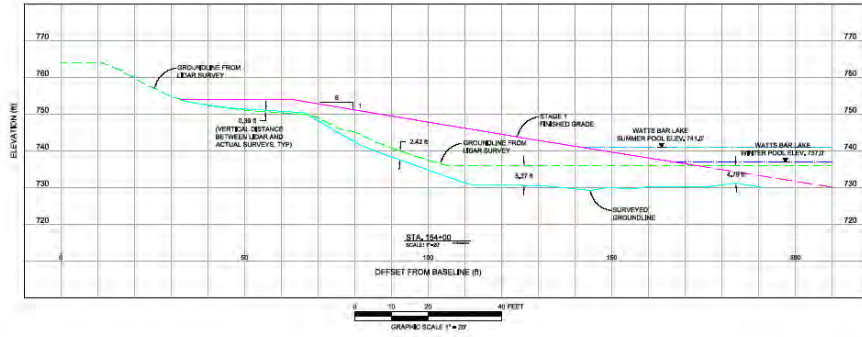
Figure 1
Kingston Fossil Plant
Dike C - Station 154+00
Starter Dike

The stability evaluation for the section at Sta 154+00 using the as-surveyed lake bottom geometry and with the buttress in place is shown on Figures 1 to 3 in Comment 4 Appendix with the results summarized in Table 4.2 below. This stability section was developed based on as-built surveyed ground geometry with subsurface soil conditions from the previously analyzed stability section at Sta 149+14. Using the same shear strength parameters and SEEP/W input file as outlined in Stantec's August 3, 2009 stability report, and under steady state conditions, the buttress design at this critical section satisfies the slope stability requirements, with Table 4.2 listing the estimated factors of safety for the various slip surfaces. The cross section at this location was also reviewed to ensure that the filter will provide an adequate factor of safety against piping. With the filter and buttress in place, the estimated factor of safety against piping is estimated to be 18.6 (Table 4.2) which is acceptable as per USACE 1110-2-1901.
